# Bathford Energy Group

## Common issues identified in a thermal imaging Project, March 2014

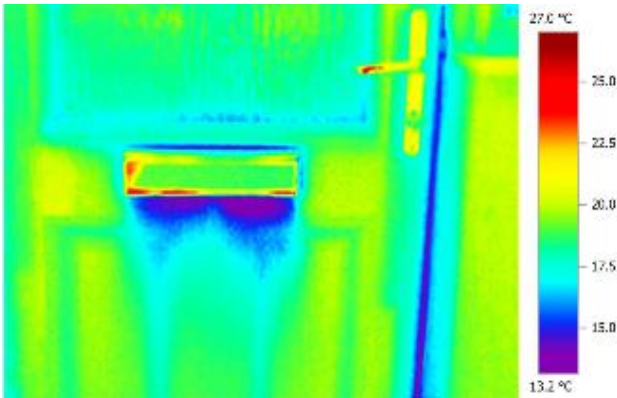
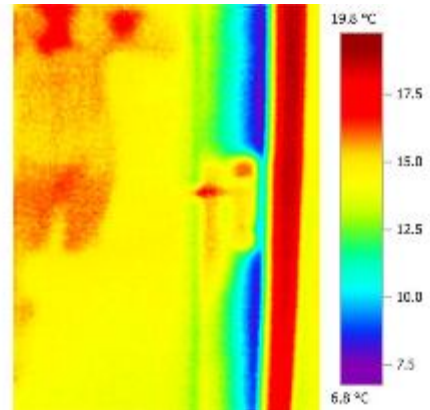
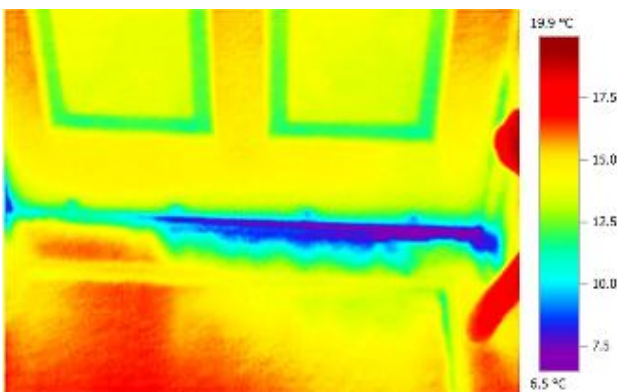
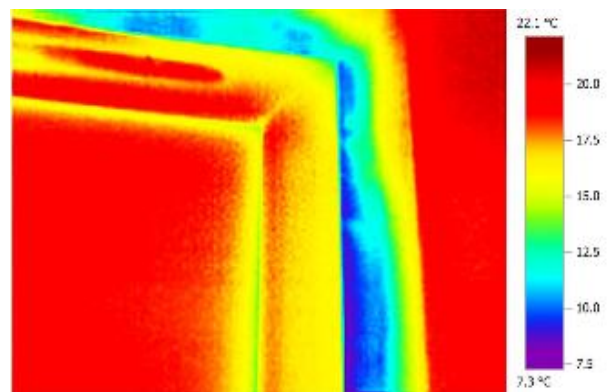
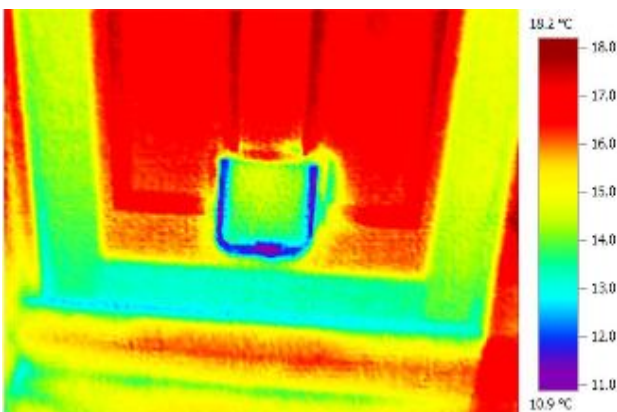
Most homes surveyed lost heat through the front door. This was through holes around cat flaps and letter boxes, or as a result of poor fit with the frame; the dark blue fronds in the pictures below show where cold air is being sucked in:

While some heat loss may be inevitable, some of these issues could be improved through checking door fittings are fully sealed into place, that letter boxes are fitted with a draught excluding strip, and that door frames fit well, with the seal strips still in good working order.

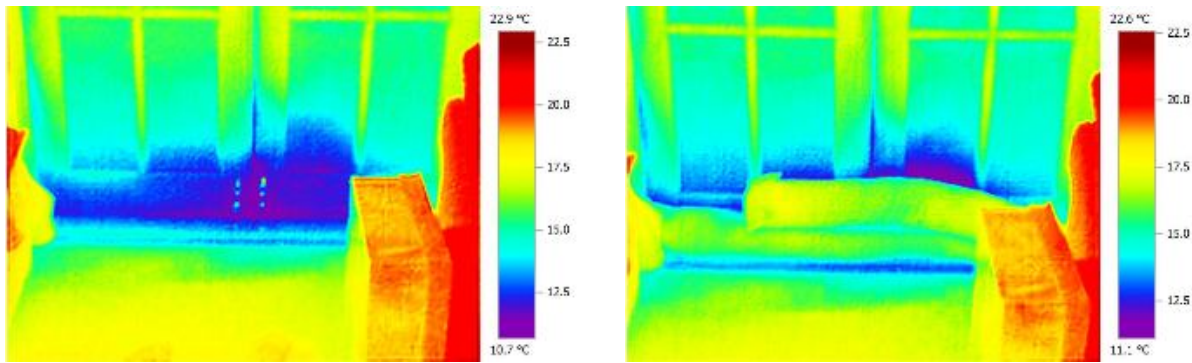
Using draught excluding filled bags (e.g., sausage dogs) can prevent some draughts, but as seen in the patio doors below pictured with and without the draught excluding bags, these don't always totally solve the problem:

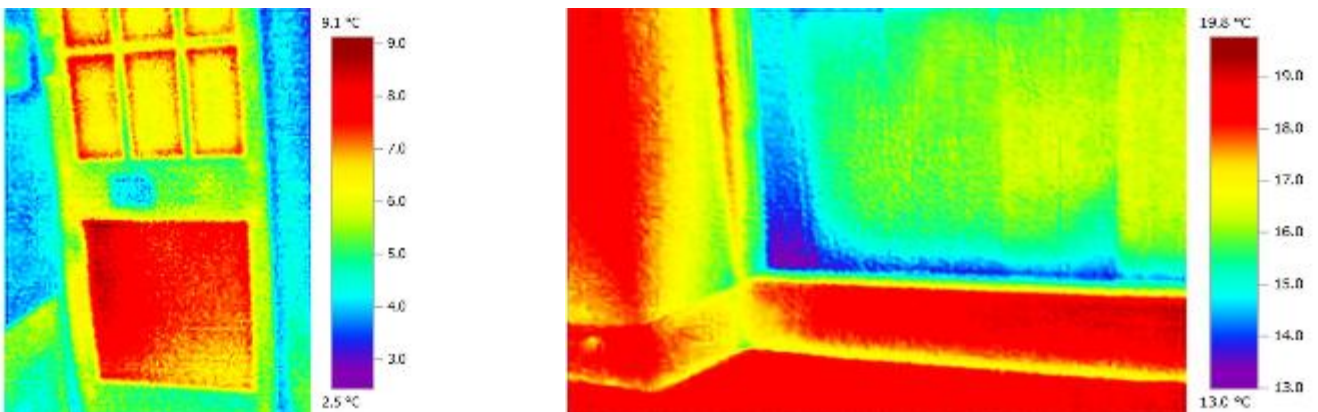
Some external doors showed big differences in temperature due to thinner (wooden) panels with poorer insulating properties. An additional insulating layer may be beneficial.

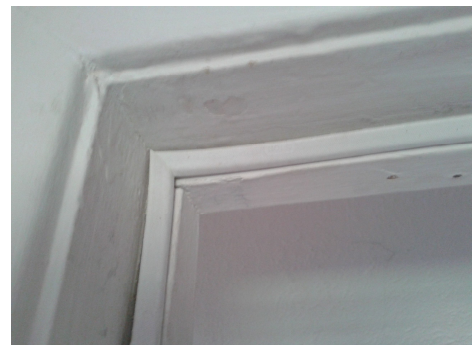
Draught excluding strips are worth adding around door frames if they not already present - this is an example fitted to an internal door:

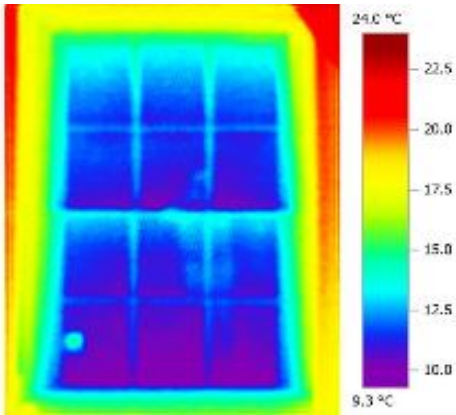
Figure 1.

These three images show the internal view of a single glazed sash window. Figure 1 is the window as it stands, with glass temperature below 12 degrees. In Figure 2, the same window has been fitted with a sheet of secondary glazing (3mm polycarbonate), and the temperature is 5 or so degrees higher. Finally, the same window was photographed with secondary glazing and the curtains closed, and is another 5 or so degrees warmer. The curtain effectively keeps the warm air from direct contact with the polycarbonate, preventing some further heat exchange.

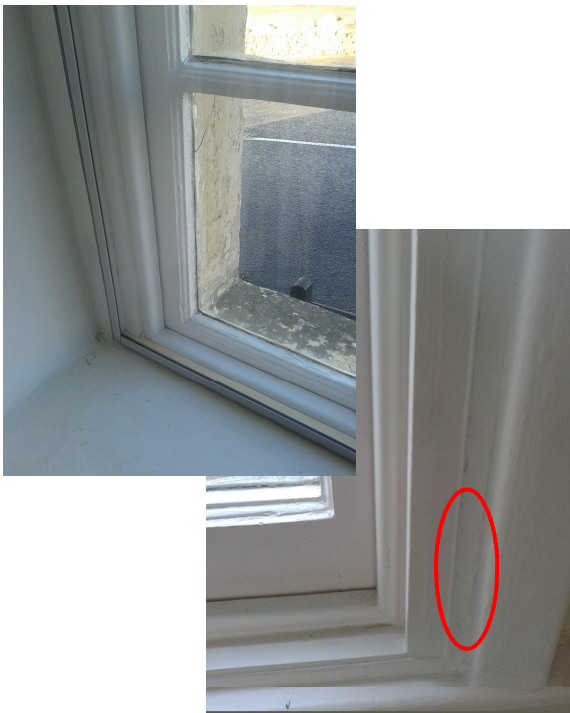
Secondary glazing can be fitted relatively inexpensively (£30-£50 per window, depending on size) through attaching polycarbonate sheets to window frames using magnetic strips (top left photo shows one in place. The magnets can be painted to blend with the window frame and are fairly invisible when in place (bottom right hand photo).

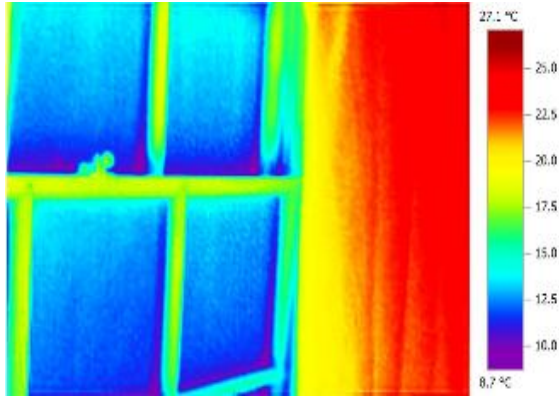
Most heat loss from windows appeared to come from poor fit—this was common in both double and single glazed units. While it can be challenging to seal gaps in sash windows if they are to fully function (Figure 4) some simple ‘stick-on’ draught excluders are available. Other window types could be more easily fitted with standard draught exclusion strips, or adjusted to better fitted to the frames.

Figure 4. Draughts around the edge of sash windows

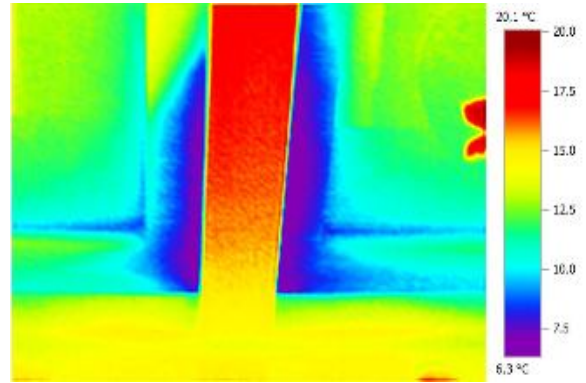
Figure 5. Draughts from poorly fitting double-glazed windows

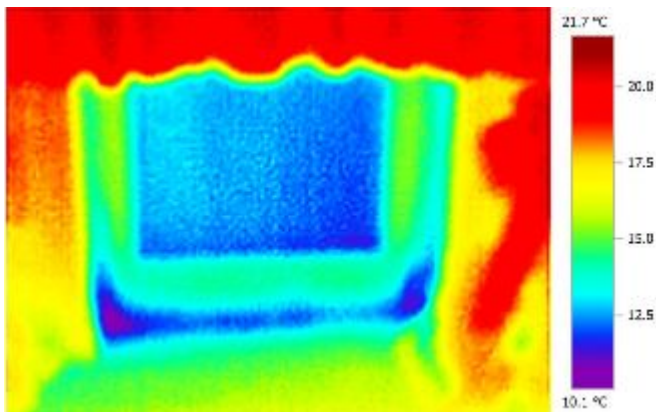
In this external door, the temperature difference is 8 or 9 degrees higher where the curtain covers the door than where it stops (the panel below is thin chipboard, which appears to be a lot less insulating than the surrounding thicker wood). Note also the draughts coming through the bottom corners of the door.

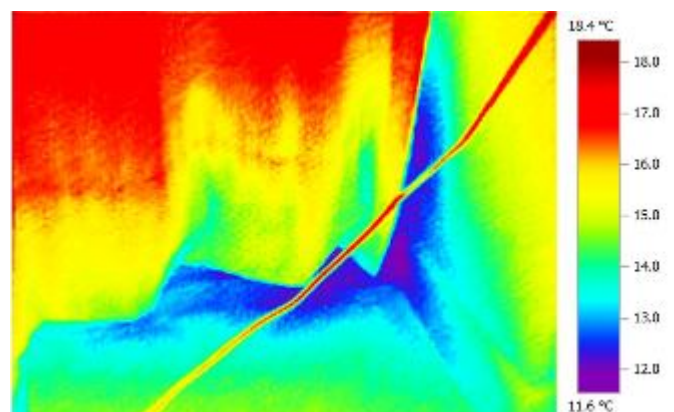
A different external door shows a similar stark difference where the curtain does not quite reach the floor or surrounding walls.

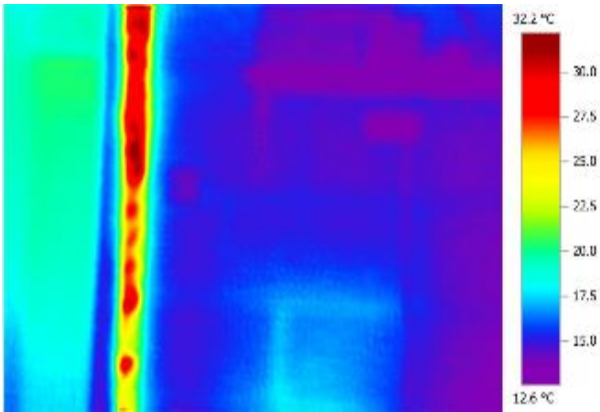
This photo shows a pipe going up the wall of a garage connected to the house. The red pipe is lagged, but shows how the insulation value of this is fairly limited (losing heat into the garage). Note the pale blue shape at the bottom of the shot —this is the outline of a heated towel rail in the bathroom behind. This wall was 4 to 5 degrees warmer than the other, fully insulated external walls, suggesting the heat from the house was escaping into the garage, and insulating this wall may well be beneficial.

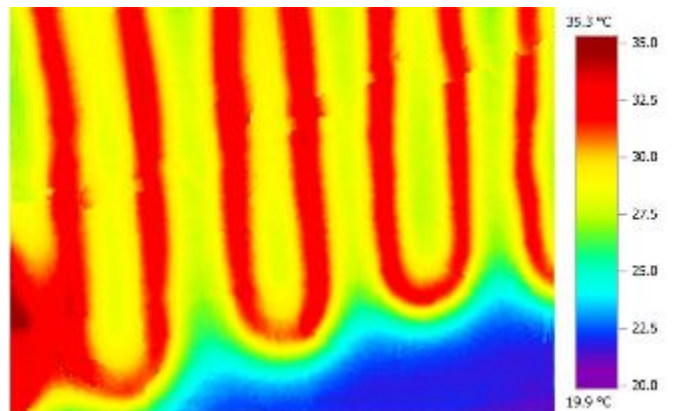
This image shows under floor heating in a bathroom. Even through the floor tiles, the temperature of the heated coils is well over 30 degrees. It may be worth considering if this temperature is necessary to retain a level of comfort.

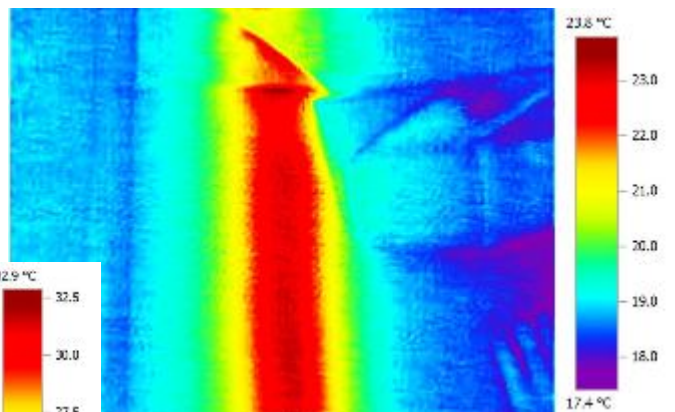
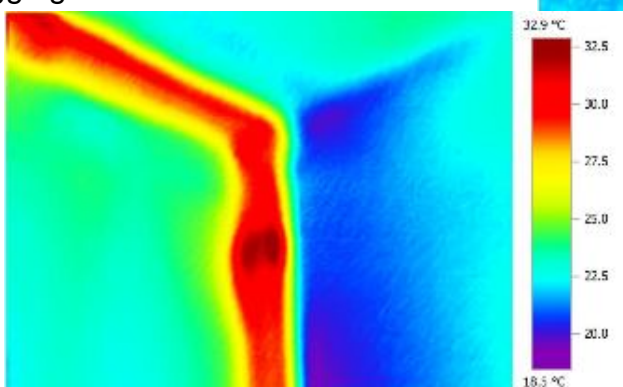
These two images show other visible pipes. On the right, this pipe is under the floorboard in an extension (i.e. heat lost to the ground).

Below, is a pipe within a plastic 'insulating' casing; while this is not such a big issue as the pipe is effectively heating the house (i.e., it is the pipe to a radiator) it demonstrates how much heat loss can take place with plastic casing but no lagging.

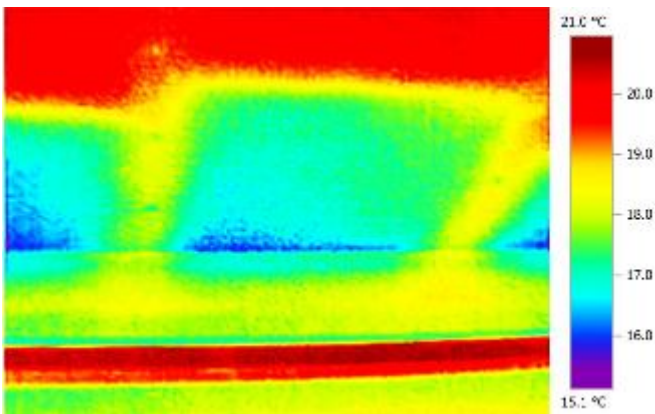
Figure 1.

Even in very well insulated homes, gaps in loft insulation in areas towards the rafters indicated areas where heat was being lost into the loft space (Figures 1 and 2). Sometimes full coverage may not be possible, but certainly worth checking.

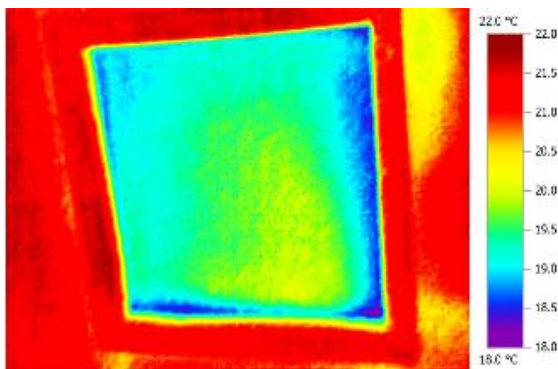
Another area of heat loss in some homes was through loft hatches. This was especially the case if the fit was poor, or the hatches themselves are made from thin materials as is the case in Figure 3. Figure 4 shows a loft hatch insulated with Kingspan, with a draught excluder fitted to the edges—this hatch shows much less variation in temperature from the surrounding ceiling that the previous figure.

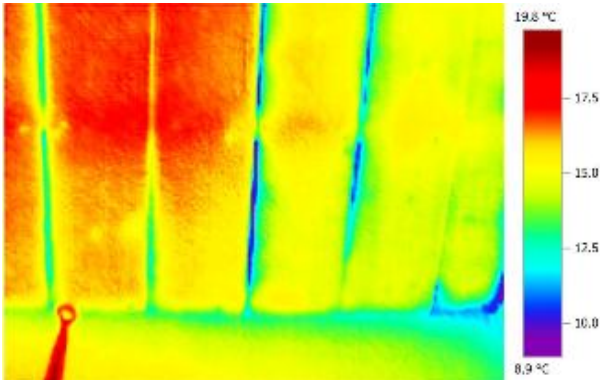
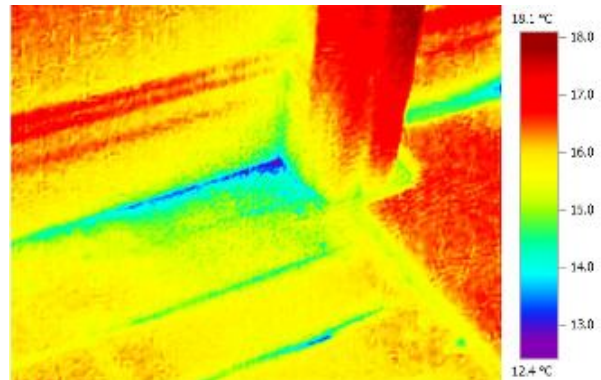
Most floors that we surveyed were carpeted, and fairly warm. However cracks between floor boards can be a source of draughts if not sealed.

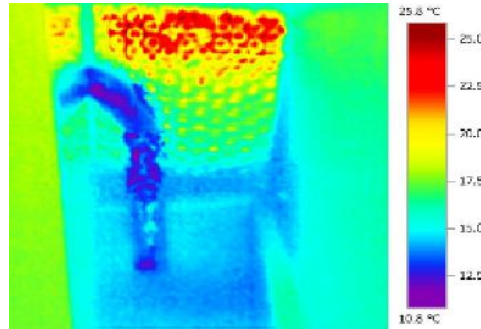
Figure 1a.

The most ingenious DIY fix we found was in insulating a cold water stop-tap. Where the tap came into the house (in a downstairs wash room), it created a cold area (Figure 1a and 1b) attracting condensation in the corner of the room. Through creating an insulated box (Figure 2a), the householder managed to retain this cold area within the box, keeping the room at a more uniform temperature (Figure 2b).

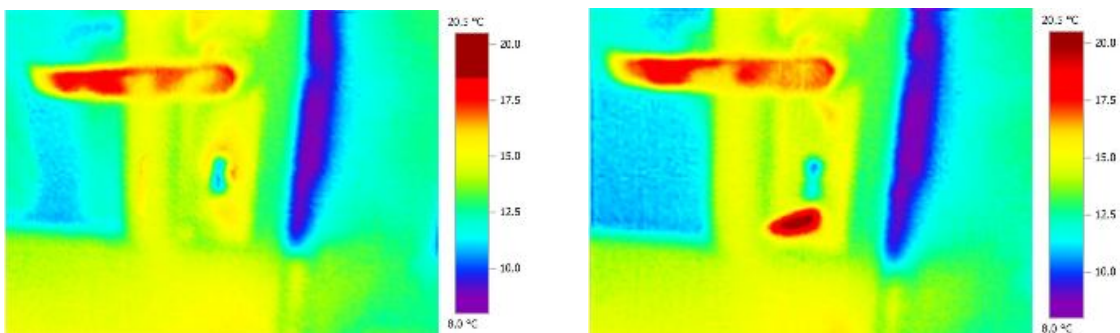
This is an example of a DIY fix to prevent the draughts coming in through the key-hole in an external door—the picture on the right has been sealed with sellotape when not in use. While this prevents the draught (and we don't want to discourage such innovation!) there is little temperature difference, and note that the draught coming in to the right of the handle (bright blue) suggests a much larger problem is caused by poor fit to the door frame. This may be a worthwhile target for next winter.....
